**Subject:** Instructions for User Interface (UI) Firmware Updates – TSX505 Undercounter Refrigerators

**Firmware Revision:** FW v1.3.00

**Description:** The TSX505 undercounter refrigerator has a new firmware update to address the lines through the display (red/orange displays). It has been determined that the previous 1.1.03 firmware update did not fully address red/orange screen issues. This UI firmware update release is to address different anomalies periodically seen on the touchscreen color display (see models impacted, Table 1)

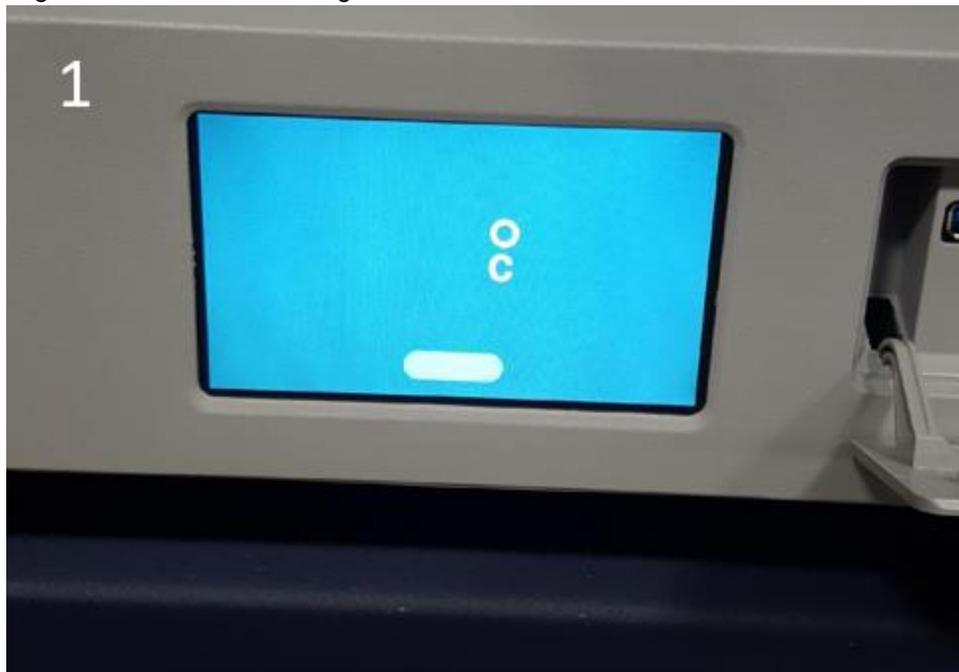
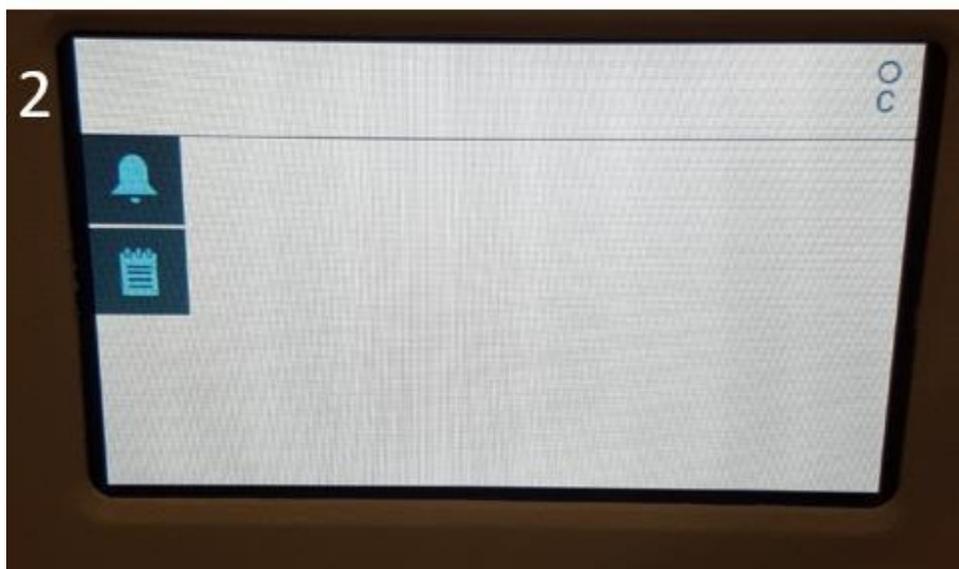
Note 3: Blank Screen Issue after UI firmware update – Blue Screen Blue/White/Blank Screen seen on TSX units with image and/or characters. Images 1 and 2 below:

Can be caused by Improper Firmware upgrade procedure: For example, removing USB during firmware update, or not following the procedure for firmware update.

The fix if the two screens above are seen: Re-Flash Firmware by re-inserting USB, hitting the middle blue button that appears on the screen, letting the USB run for 20 seconds, then hitting reset. This will then cause the screen to return to a normal state.

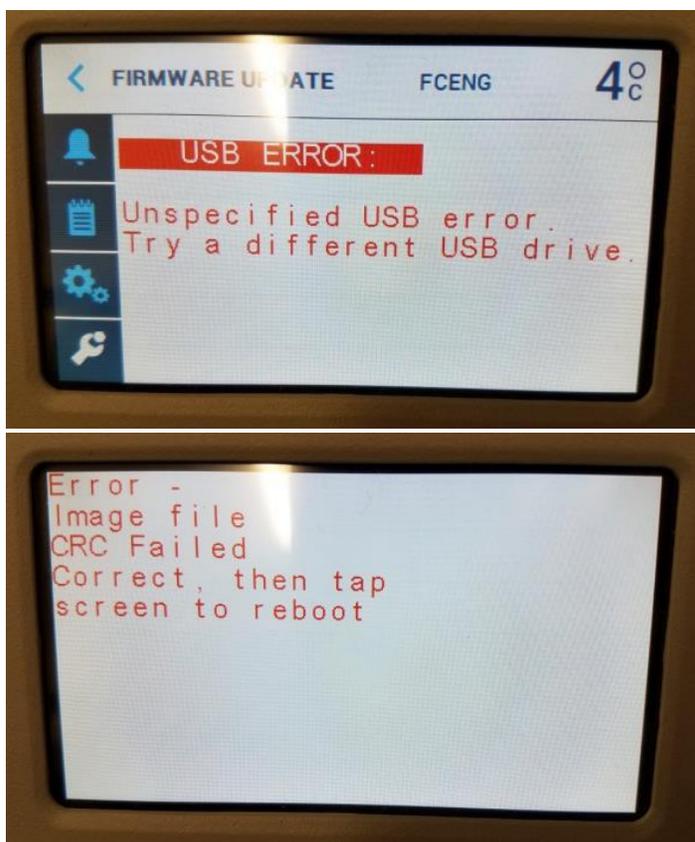
*Note 4: USB Error message during UI firmware update*

*If the Firmware files were loaded into a folder instead of the root directory of the USB drive, when the "Apply" option is selected, the following two screens appear and the unit will reboot. Tap the screen to reboot. The unit will operate normally under the original firmware and show a power fail alarm.*

**Solution:** move the two files to the root directory of USB storage device and start the process over.
