Application Note: 52126

XPS Analysis of Defects on Painted Surface

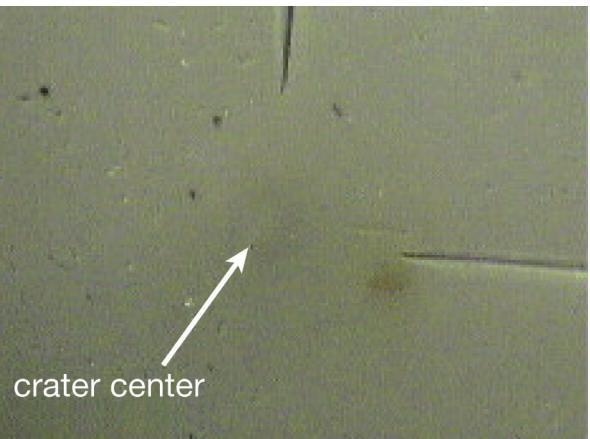
An image from the Reflex optics system is shown in Figure 1 (crater center indicated with an arrow). XPS images of the defect were collected by rastering the stage under the X-ray beam and collecting 128-channel snapshot spectra at each point. The one-click charge compensation system was used as the painted film was electrically insulating.

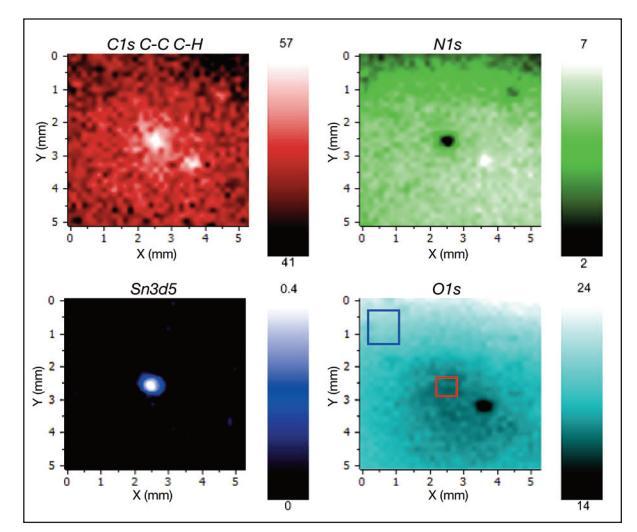
Figure 2: XPS atomic percent images of the crater for relevant chemical states. The indicated areas in the O1s image denote the pixels averaged to generate the spectra in Figure 3. A secondary defect can also be seen most noticeably in the O1s image to the lower right of the center, which appears to have a different cause.

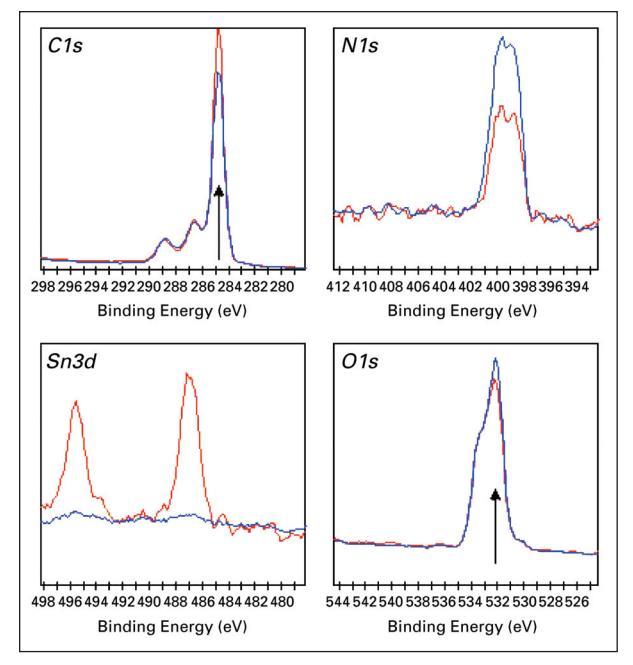
Figure 3: Average spectra generated from the center of the crater (red) the left side of the crater (blue)

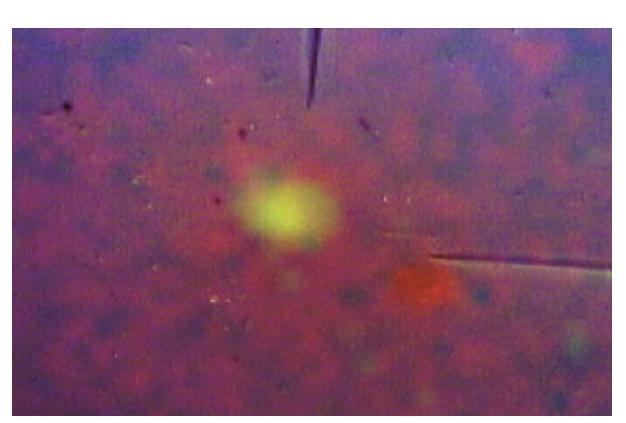
Figure 4: Overlay of the XPS images and the live optical view. C1s(C-C) is red, Sn3d5 is green, and O1s is blue
