Figure 1: Thermo Scientific Nicolet iS 5 FT-IR Spectrometer with Diamond ATR accessory. Source: Thermo Fisher

# Identifying Failures and Ensuring Quality of Plastic Materials

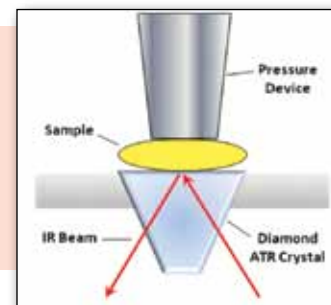
Figure 2: Schematic representation of diamond ATR accessory. Source: Thermo Fisher

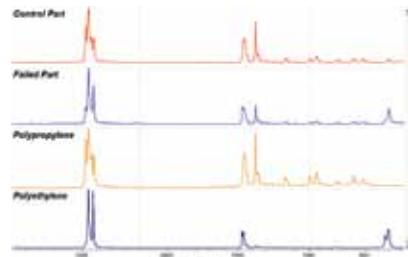
Figure 3: Spectra of control and failed parts along with reference spectra of pure polyethylene and polypropylene. Source: Thermo Fisher

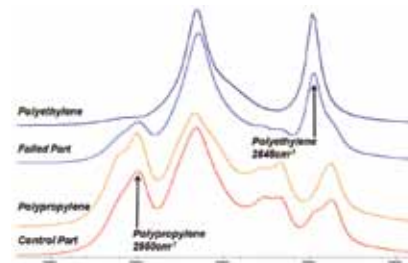
Figure 4: Expanded hydrocarbon stretching showing stronger polyethylene characteristics in the failed part. Source: Thermo Fisher

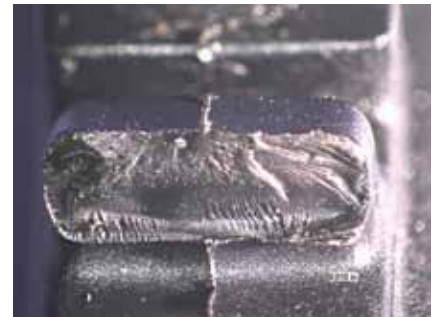
Figure 5: The fracture surface is shown with crack initiation at an inclusion. Source: Thermo Fisher

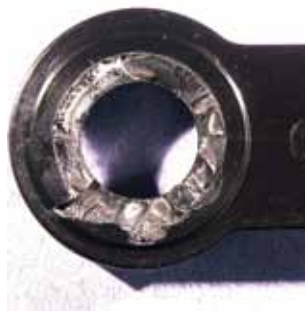
Figure 8: The failed bracket fracture surfaces exhibited features characteristic of environmental stress cracking (ESC). Source: Thermo Fisher

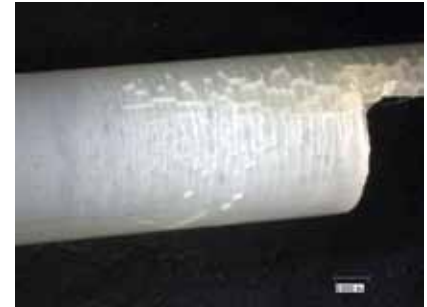
Figure 11: The tubing showed a series of parallel transverse cracks with brittle fracture features. Source: Thermo Fisher
