## 49iQPS Plumbing Update

A copy of the installation instructions are included after this tech note so you may understand the actions required (a copy also accompanies the upgrade kit). Thank you.

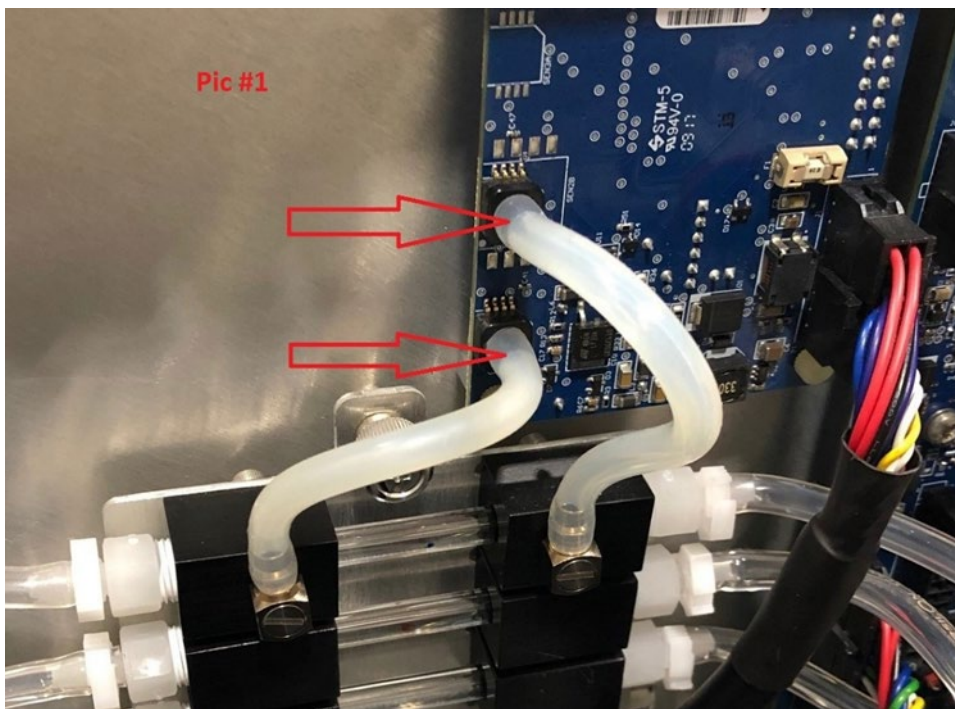
b. Follow each piece of tubing from the capillary plate & disconnect at the opposite end (new tubing is provided so cutting the tubing would be easiest)

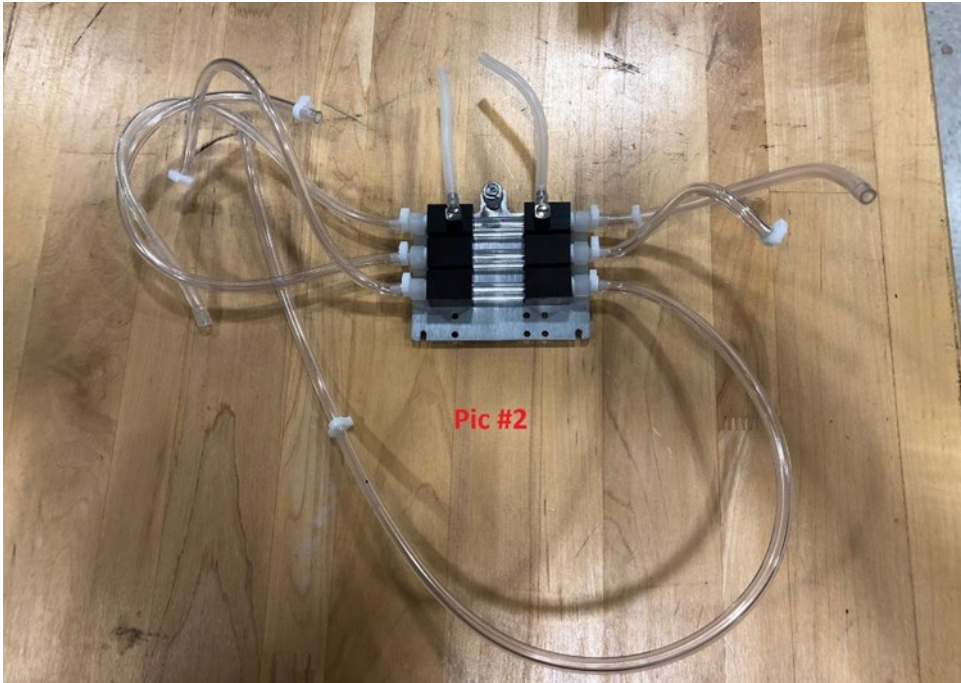
2. Remove the Flow/Pressure board by disconnecting the DMC cable and loosening the (4) hex screws (see pic #3 below)

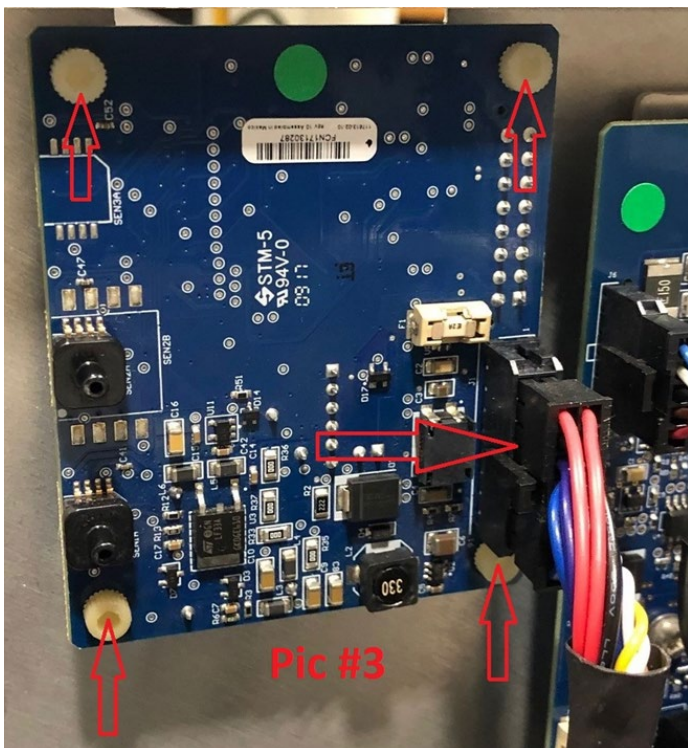
3. Install the new Flow/Pressure board found in the kit. Plug DMC cable back in
4. Replace both fittings on the detector end of the Photometer with new elbow fittings found in the kit (both fittings should face upwards) (see pic #4 below)

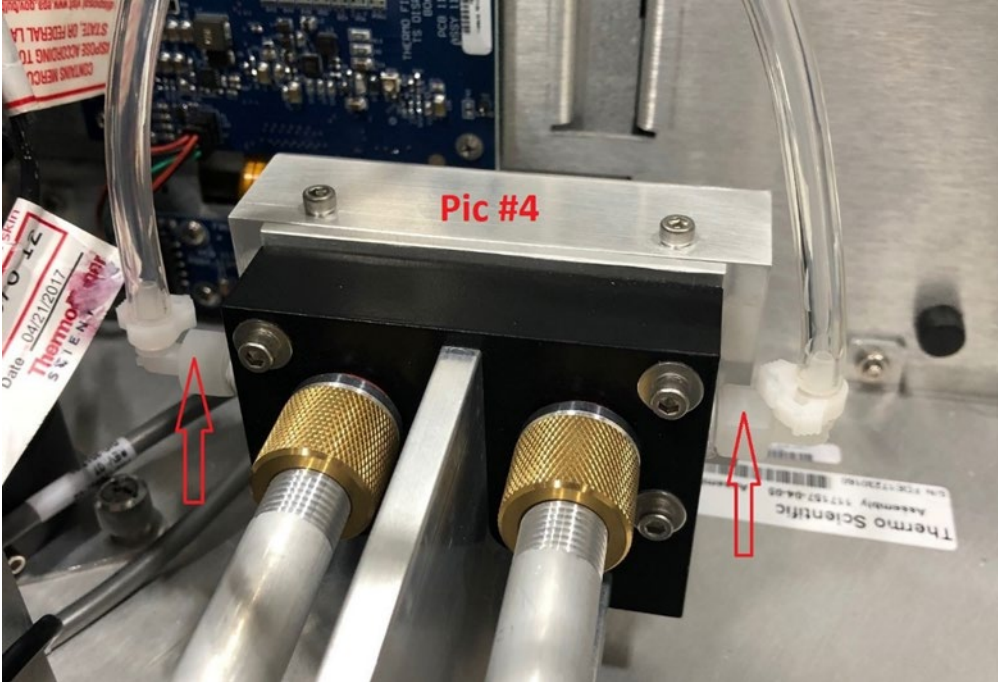
5. Install the new capillary plate assembly found in the kit.
  - a. Place plate on the two standoffs & tighten the captive screw
  - b. Connect the tubing from the capillary plate to the correct components (see chart)
6. Load the latest 49iQPS firmware
7. After the firmware upgrade is complete, you must enable this feature (see instructions below).

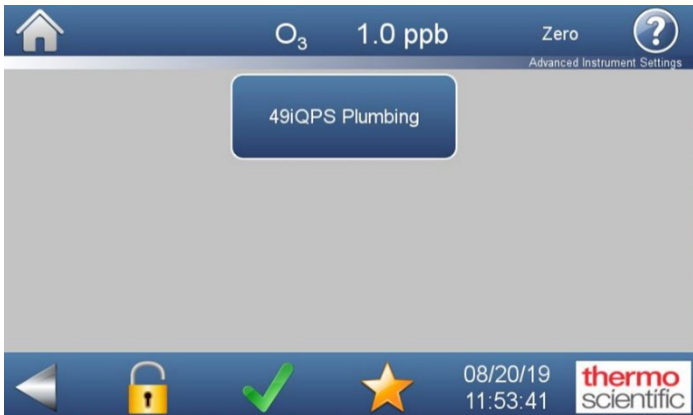
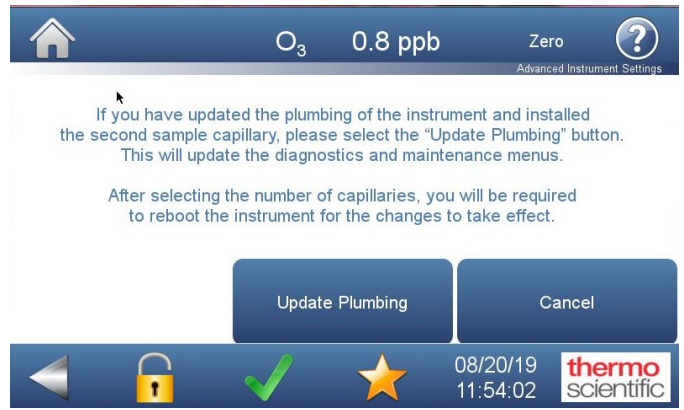
49iQPS Plumbing Chart		
From	To	To
Pump Intake	Divider Panel, Top Clip	"Y" fitting to top two capillaries
Top capillary, left SS elbow fitting	Flow/Pressure board, bottom port	
Top capillary, right SS elbow fitting	Flow/Pressure board, middle port	
Top capillary, left fitting	"Y" fitting from pump intake	
Top capillary, right fitting	Photometer, detector side, right elbow	
2nd capillary, right SS elbow	Flow/Pressure board, top port	
2nd capillary, left fitting	"Y" fitting from pump intake	
2nd capillary, right fitting	Photometer, detector side, left elbow	
3rd capillary, left fitting	Regulator "Y" fitting	
3rd capillary, right fitting	Ozonator Intake (middle fitting)	
Bottom capillary, left fitting	Regulator "Y" fitting	
Bottom capillary, right fitting	Reference Solenoid "Y" fitting
