Countess™ 3 and 3FL Automated Cell Counters: Troubleshooting Guide

Software Updates and Technical Issues

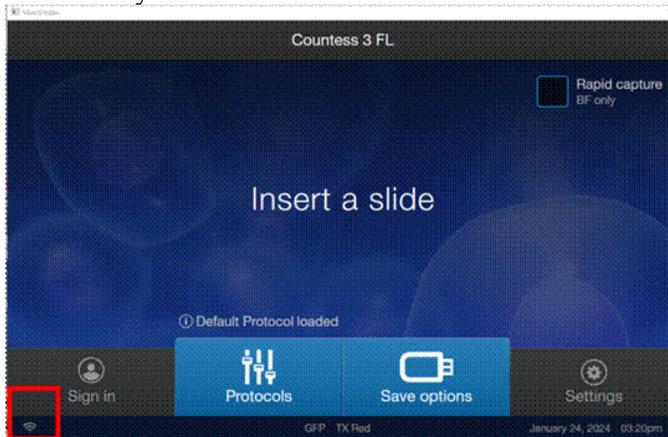
Check if other instruments with Wi-Fi connectivity are also experiencing similar issues. Test the Wi-Fi connectivity of the Countess instrument with a mobile hotspot. If mobile hot spot is working, then it would indicate issues with the Wi-Fi signal in the lab.

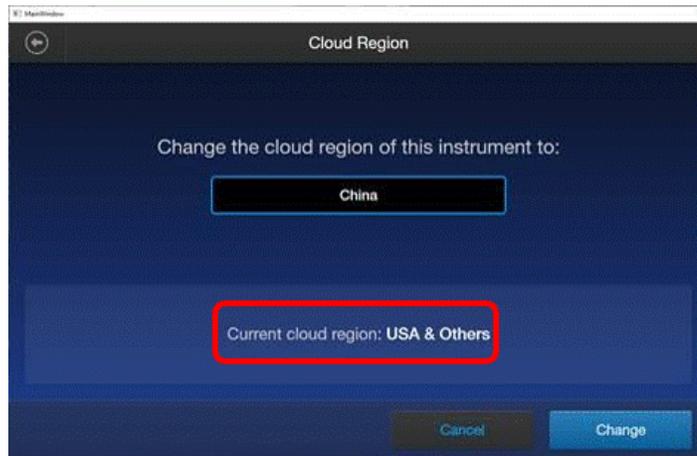
6) Step 6: File format
