# TaqMan<sup>®</sup> OpenArray<sup>®</sup> Genotyping

Publication Number MAN0011115 Revision A.0

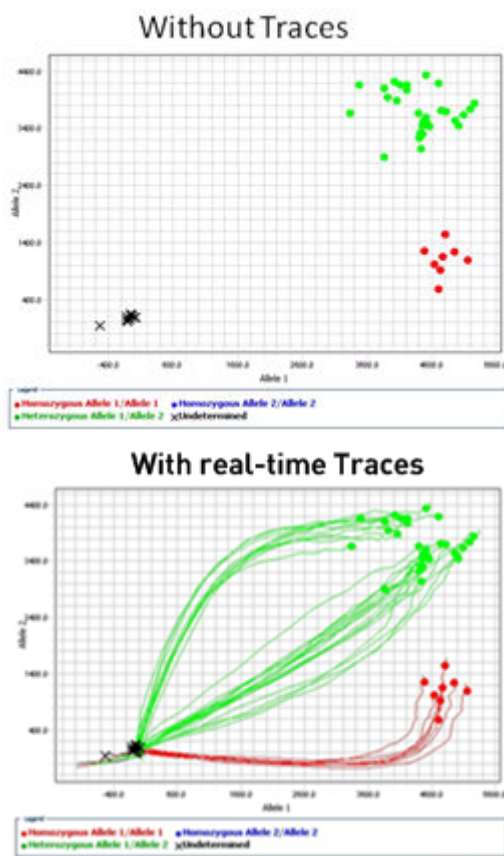
SNP assay real-time traces can also be viewed using the genotyping data analysis tools in the Applied Biosystems® qPCR Analysis Module, which is accessed from the [www.lifetechnologies.com](http://www.lifetechnologies.com) web site.

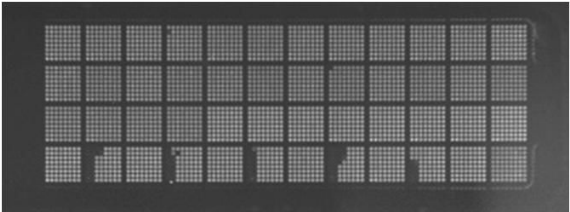
Not enough volume of sample was added to the 384-well sample plate.	Ensure that proper pipetting techniques are performed. Ensure that there are no air bubbles in the pipette tips after sample aspiration.
	Reaction mix (sample + master mix) is not at the bottom of the 384-well sample plate.	Ensure that the sample plate is centrifuged at 1000 rpm for 60 seconds.
Turn-holes are repeatedly missed

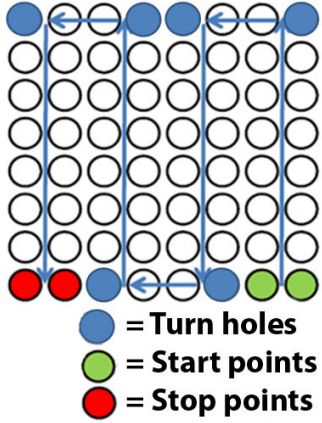
<p> <span style="color: blue;">●</span> = Turn holes  <span style="color: green;">●</span> = Start points  <span style="color: red;">●</span> = Stop points         </p>	Contact your local field service engineer to resolve the issue.

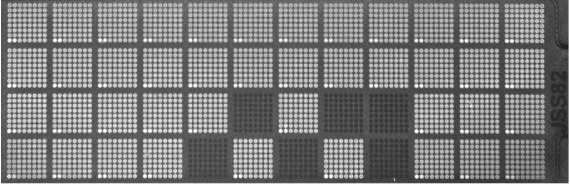
Sample/Master Mix not added to particular wells in the 384-well sample plate.	Visually inspect the sample plate to confirm that the wells have sample/ master mix.
	Stuck tip mandrel on AccuFill™ instrument may need cleaning.	Contact your local field service engineer.
	Pipette tip not loaded on mandrel.	Contact your local field service engineer if this happens regularly (infrequent occurrences can be due to a poorly molded tip).

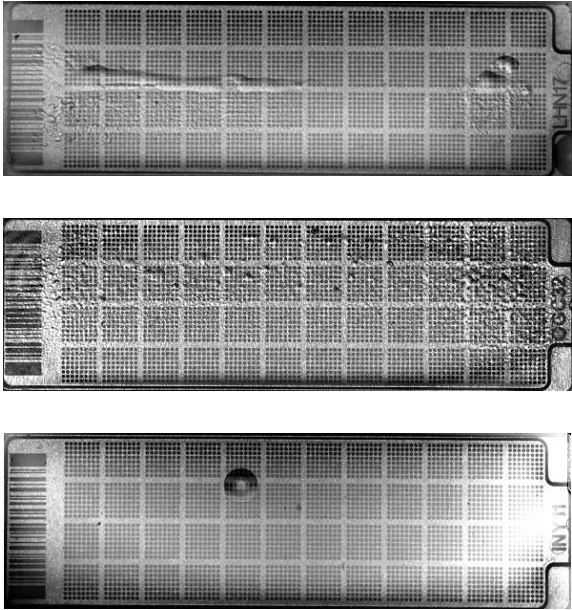
<p>Improper sealing of the OpenArray® plate in the OpenArray® Case can lead to immersion fluid leaks or bubble formation inside the case, leading to uneven heating and imaging throughout PCR and to poor quality genotyping data.</p> <p>The images above are examples of OpenArray® plates that have been affected by immersion fluid leaks. The images show where leaked fluid has condensed on the underside of the heated cover windows and obscured the view of the through-holes.</p> <p>The best image in which to detect leaks is the s03_c001_t03_p0001_m2_x3_e1_cp#_spotfind.tiff image. This image is taken at the start of cycling, which is where most leaks occur. See “Troubleshoot with cycling and imaging run images” on page 1.</p>	Plate press was not engaged for at least 20 seconds.	Ensure that the plate press is fully engaged for at least 20 seconds on future experiments.

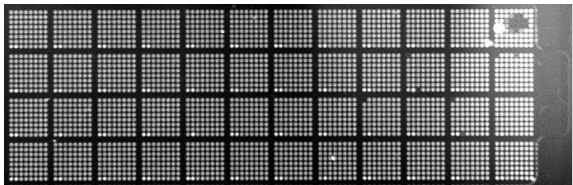
<p>The reactions in A12 were compromised during the addition of immersion fluid. Injecting the immersion fluid too quickly can actually purge the sample out of the through-holes near the fill port. Often this is caused by the user not purging the syringe slightly before use.</p>	<p>A small amount of immersion fluid should be dispensed onto a paper towel before use to ensure smooth operation of the syringe.</p>
<p>Evaporation of reaction mixture in through-holes</p>

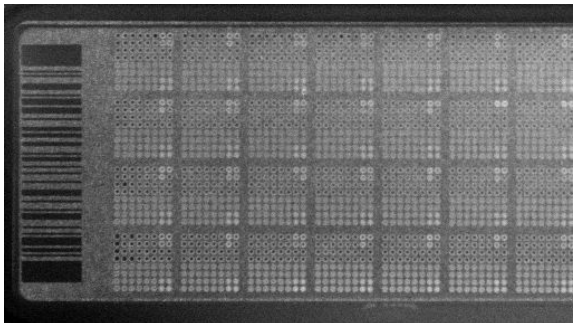
<p>Too much time elapsed before plate was sealed with lid and immersion fluid. In this example, the top half of each subarray was intentionally left open to the environment to demonstrate the effect of evaporation. "Donuts" are a result of the evaporated fluid in the through-holes.</p>	<p>To minimize the likelihood of evaporation, take the plate off of the AccuFill™ deck, seal the case with the lid, and add immersion fluid as soon as the case is removed from the plate press</p>

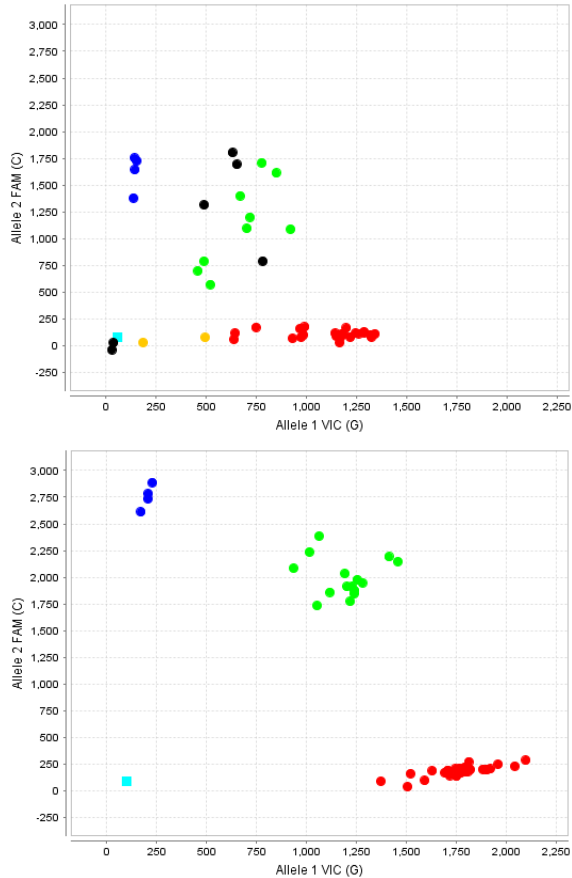
<p>The top scatter plot shows Allele 2 FAM (C) on the y-axis (ranging from -250 to 3,000) versus Allele 1 VIC (G) on the x-axis (ranging from 0 to 2,250). It displays several diffuse clusters of points in blue, green, black, and red, indicating poor data quality. The bottom scatter plot shows the same axes but with much more distinct and well-separated clusters of points, indicating improved data quality after preamplification.</p>
