XPS Analysis of Defects on Painted Surface

Author Tim Nunney, Thermo Fisher Scientific, East Grinstead, West Sussex, UK

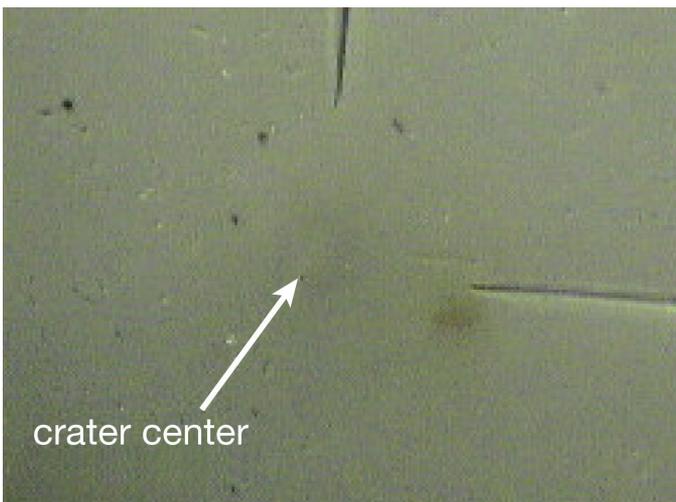
Figure 1: Optical view of the crater defect. The limits of the defect indicated by horizontal and vertical score lines.

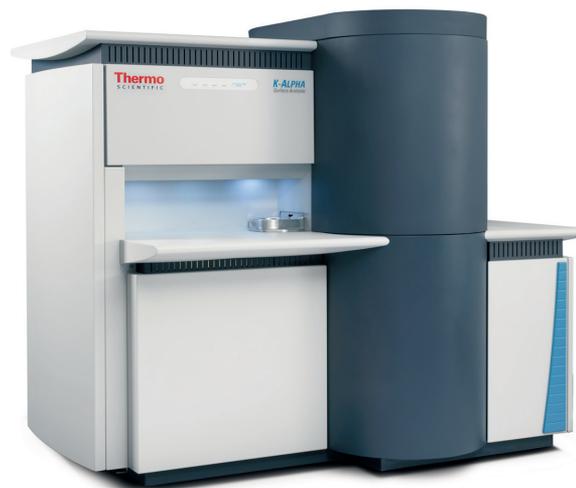
Thermo Scientific K-Alpha XPS

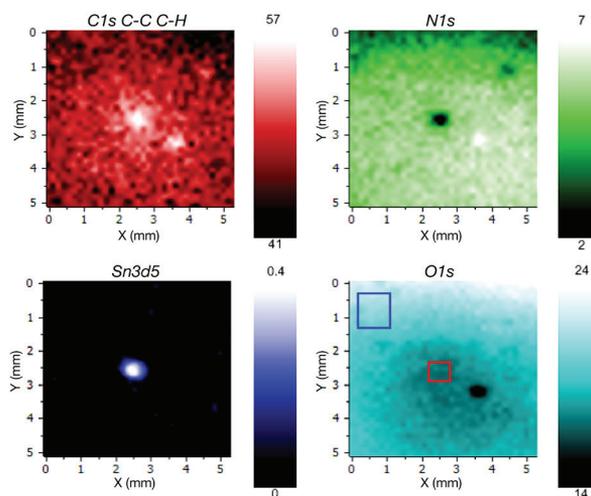
Figure 2: XPS atomic percent images of the crater for relevant chemical states. The indicated areas in the $O1s$ image denote the pixels averaged to generate the spectra in Figure 3. A secondary defect can also be seen most noticeably in the $O1s$ image to the lower right of the center, which appears to have a different cause.

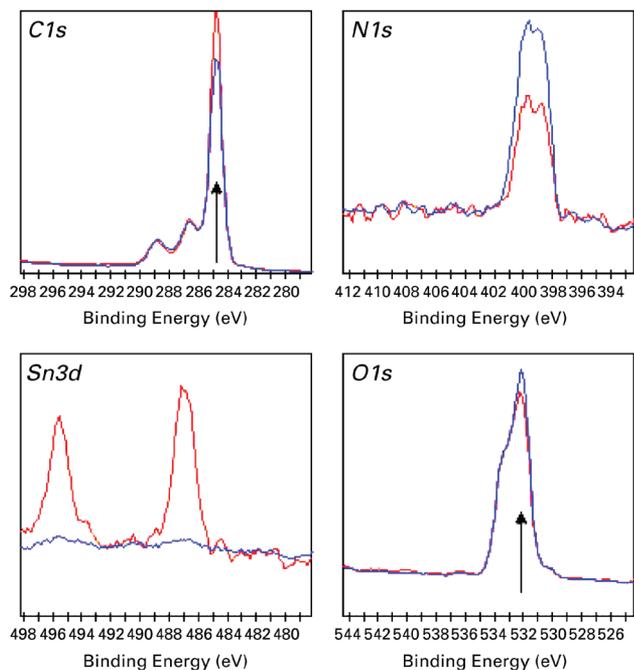
Figure 3: Average spectra generated from the center of the crater (red) the left side of the crater (blue)

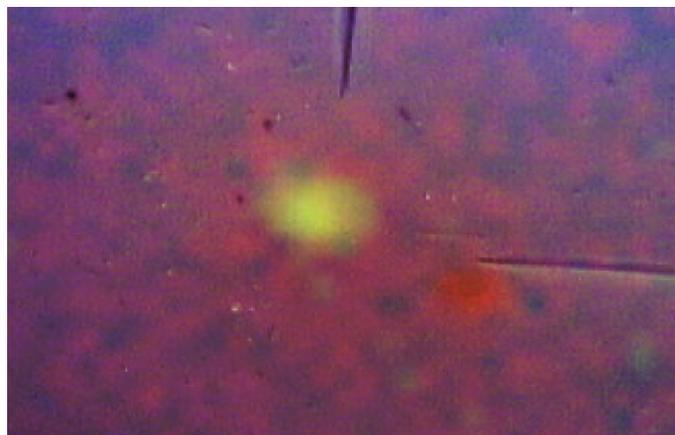
Figure 4: Overlay of the XPS images and the live optical view. *C1s(C-C)* is red, *Sn3d5* is green, and *O1s* is blue
