Identifying failures and ensuring quality of plastic materials

Jeffrey Jansen, The Madison Group
Mike Garry, Thermo Fisher Scientific

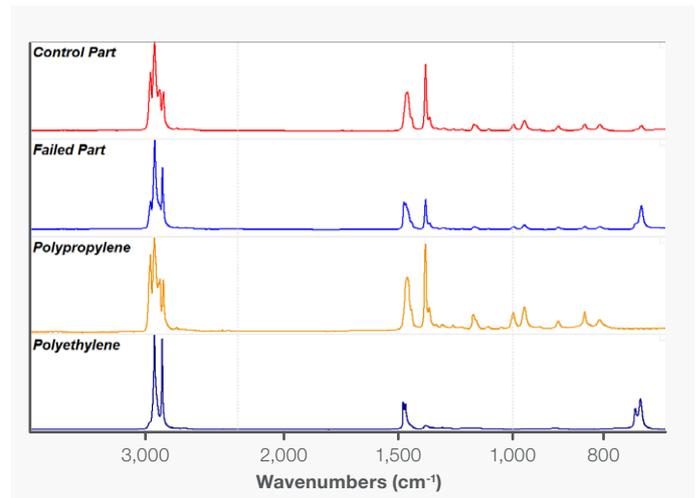
Figure 3. Spectra of a control and a failed plastic fastener, along with reference spectra of pure polyethylene and polypropylene.

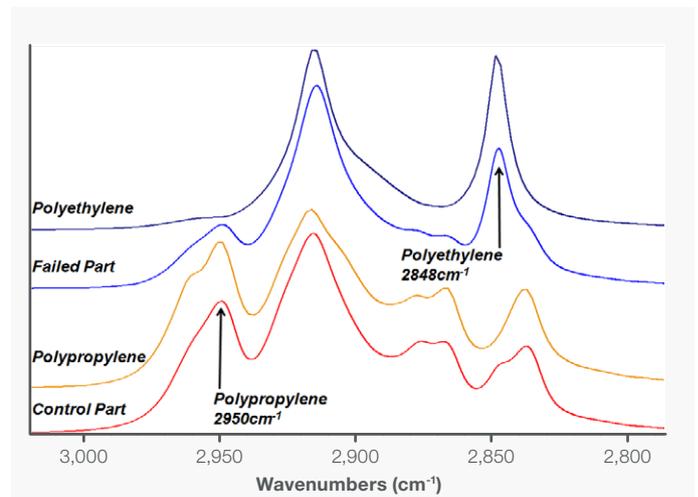
Figure 4. Expanded hydrocarbon stretching showing stronger polyethylene characteristics in the failed part.

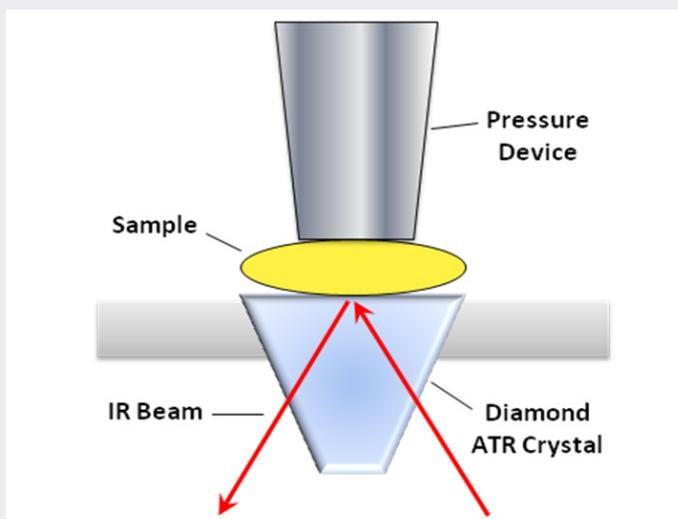
Figure 2. Schematic representation of a diamond ATR accessory.

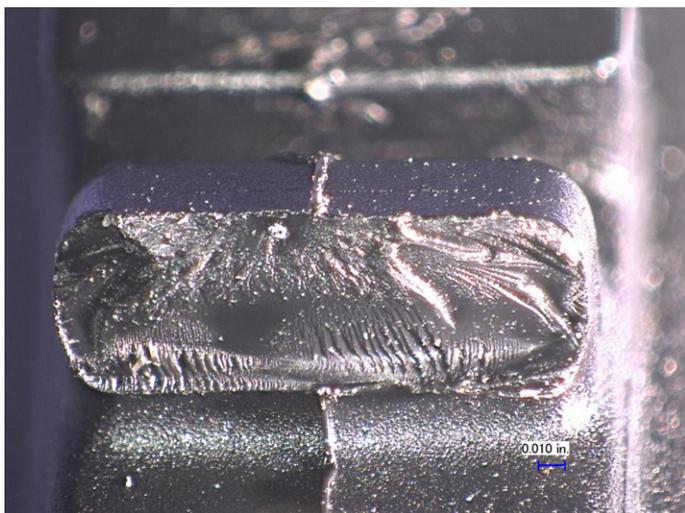
Figure 5. The fracture surface is shown with crack initiation at an inclusion.

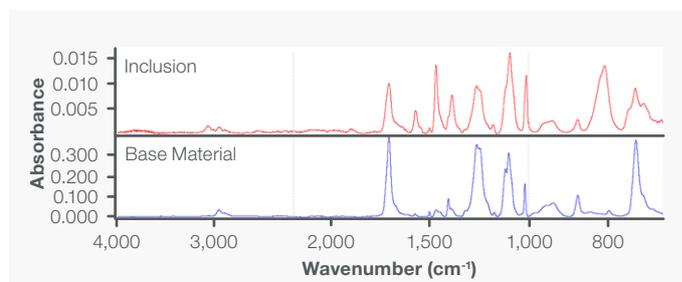
Figure 6. FTIR spectrum showing that the inclusion in the valve sample contained additional absorption bands in comparison with the base material.

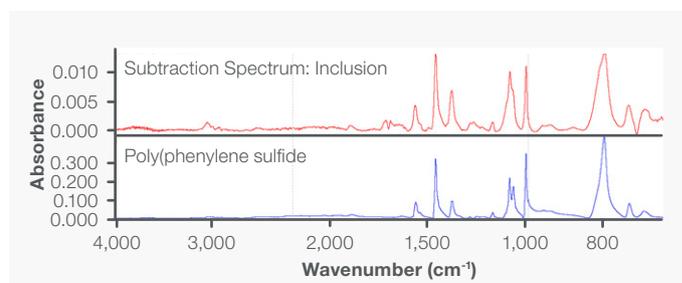
Figure 7. Spectral subtraction of the inclusion minus base material resulted in a spectrum characteristic of PPS.

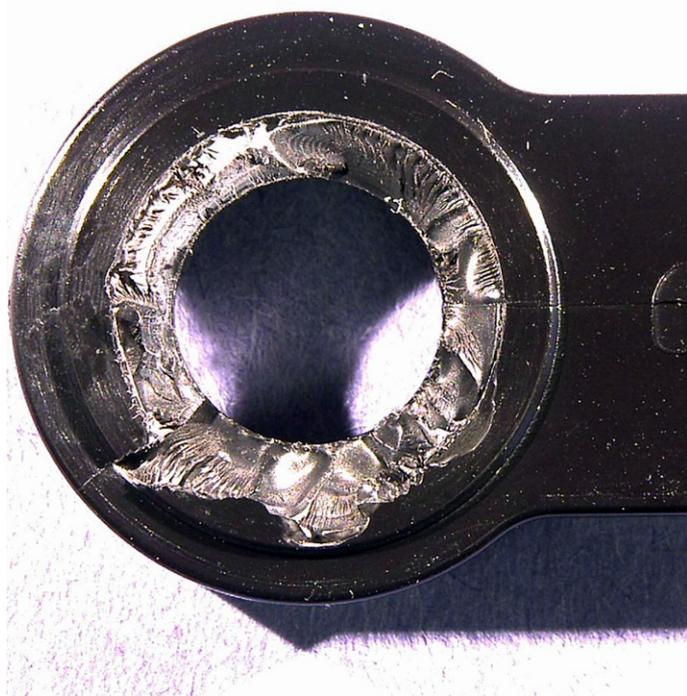
Figure 8. The failed bracket fracture surfaces exhibited features that are characteristic of environmental stress cracking (ESC).

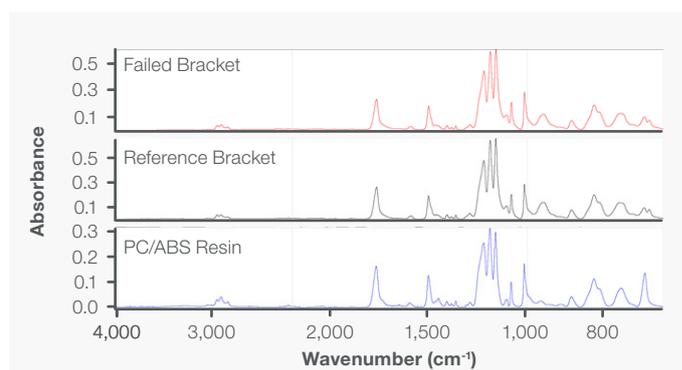
Figure 9. The FTIR spectra representing the failed and reference brackets contained absorption bands indicative of a PC+ABS resin.

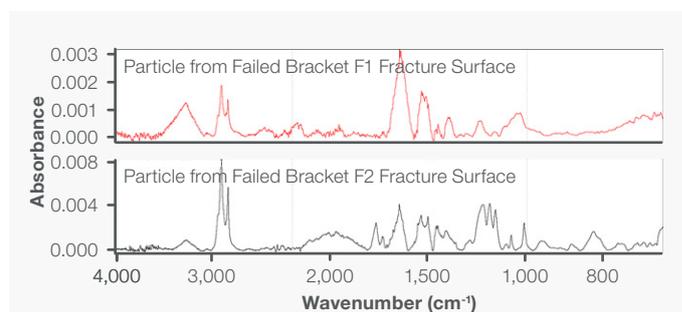
Figure 10. FTIR spectra obtained on the bracket fracture surfaces contained absorbances associated with organic esters.

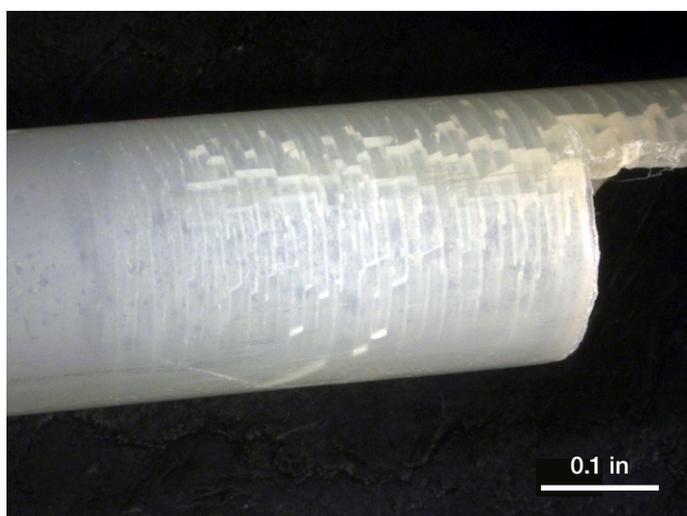
Figure 11. Broken tubing, showing a series of parallel transverse cracks with brittle fracture features.

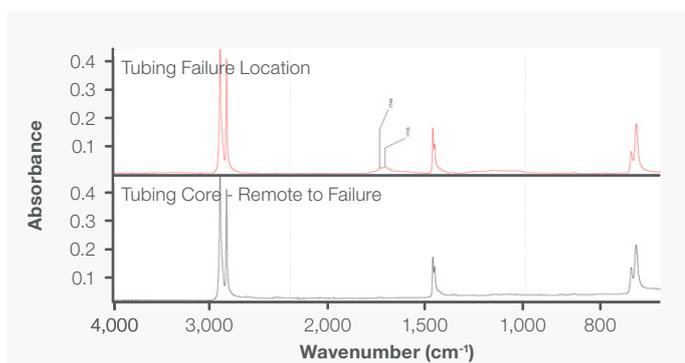
Figure 12. The FTIR spectrum of the failure location in the broken tubing exhibited carbonyl bands associated with the degradation of polyethylene resins.
