# Investigating why a plastic part failed

## Key words

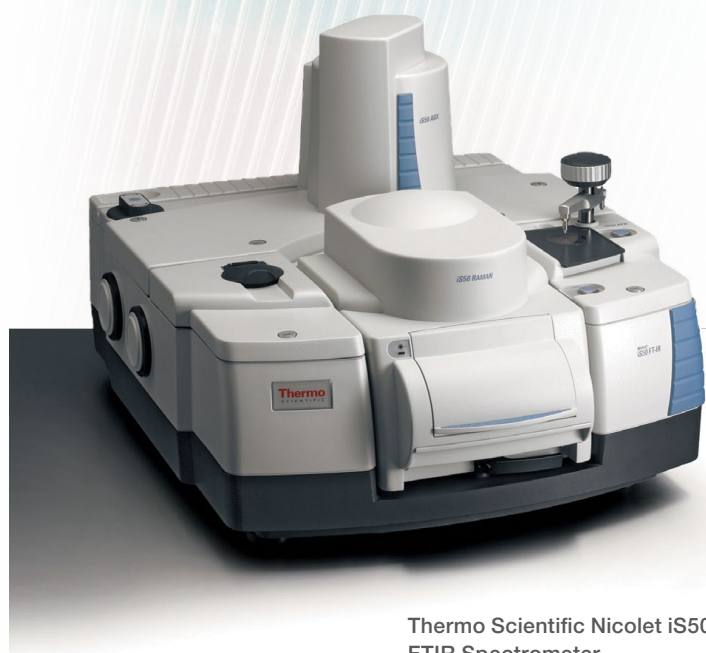
Thermo Scientific Nicolet iS50  
FTIR Spectrometer

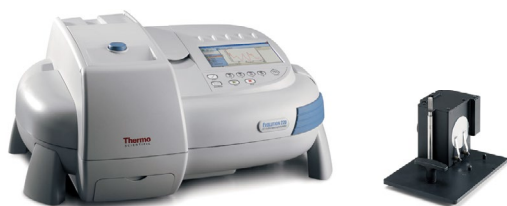
Figure 1: Evolution 220 UV-Visible Spectrophotometer (left), and sample compartment integrating sphere accessory (right)

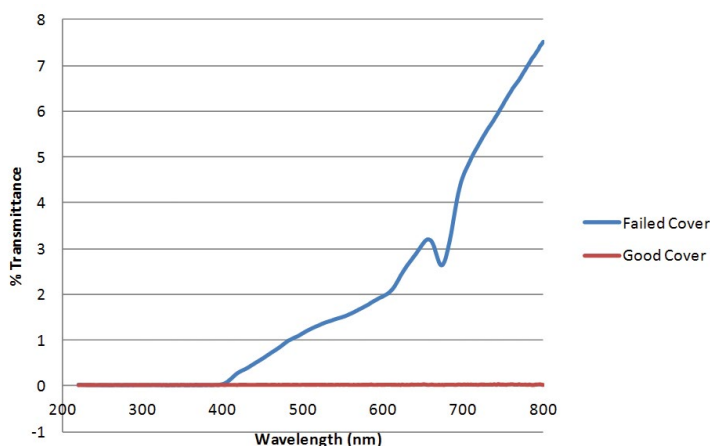
Figure 2: Diffuse Transmittance UV-Visible spectra of the failed cover (blue) and good cover (red), collected with an Evolution 220 UV-Visible Spectrophotometer and integrating sphere accessory

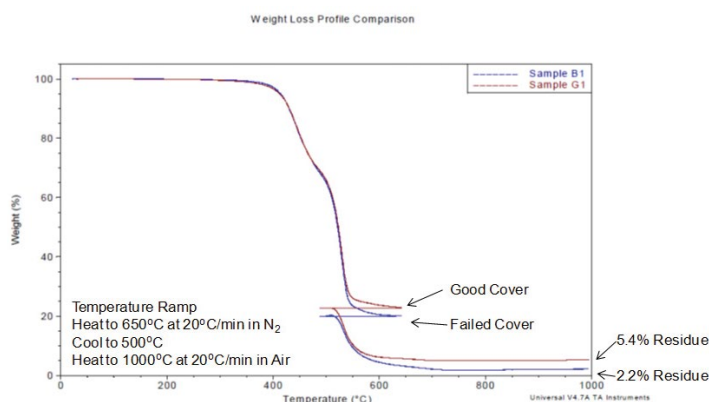
Figure 3: Thermogravimetric analysis weight loss curves for the good cover (red) and failed cover (blue), showing that the good cover has significantly higher inorganic content than the failed cover

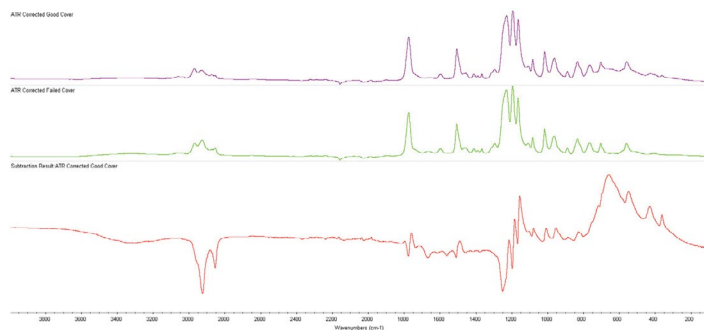
Figure 5: Advance ATR corrected infrared ATR spectra of the good plastic cover (top), failed plastic cover (middle) and difference spectra between the two (bottom)

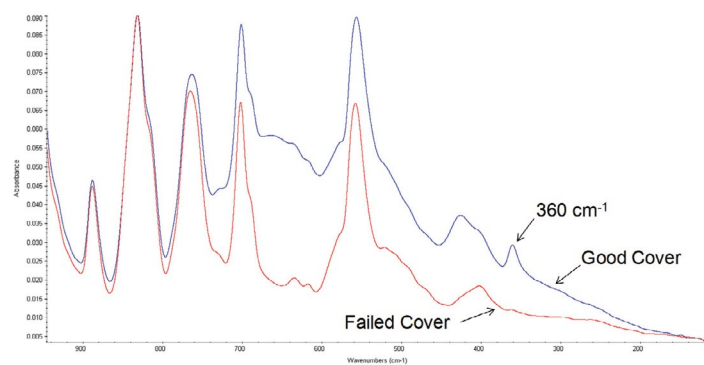
Figure 6: Overlay of the advanced ATR corrected spectra of the good cover (blue) and failed cover (red), over the spectral region from 940 to 100  $\text{cm}^{-1}$ . Note the elevated baseline and the absorbance band at 360  $\text{cm}^{-1}$  in the spectrum of the good cover that are absent or highly reduced in the spectrum of the failed cover.

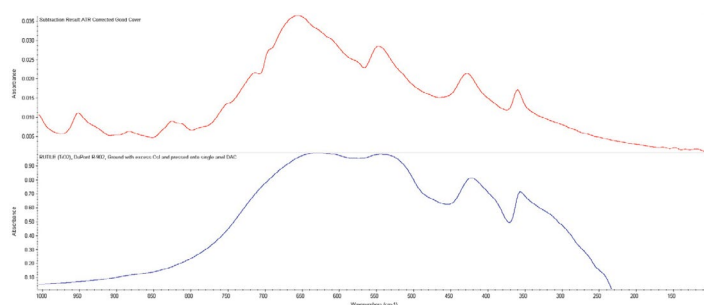
Figure 7: FT-Raman difference spectrum between the good and failed covers (blue), and top match from a library search against a forensic automobile paint pigment and fillers library (red), identifying a higher concentration of rutile (titanium dioxide) in the good cover.

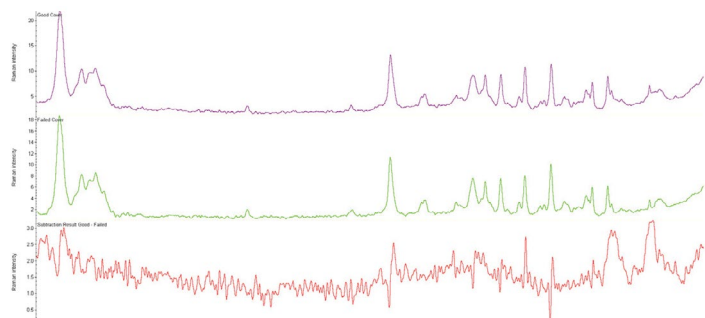
Figure 8: FT-Raman spectra of the good cover (top), failed cover (middle), and subtraction result between the two (bottom)

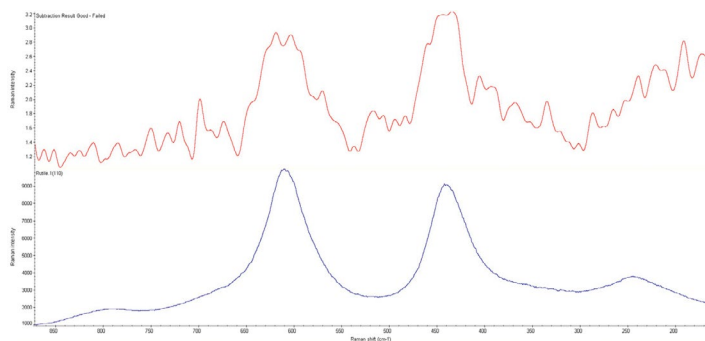
Figure 10: FT-Raman difference spectrum between the good and failed covers (top), and top library search result against a minerals Raman library (bottom), identifying a higher concentration of rutile (titanium dioxide) in the good cover
