Investigating automobile paint chip layers with FTIR and Raman microscopy

Introduction

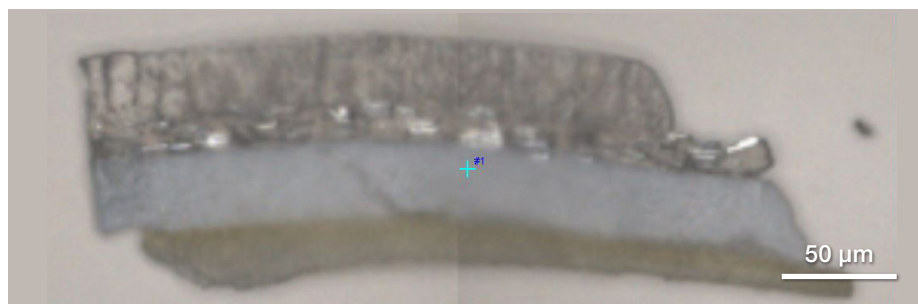
Figure 1. Schematic of a typical four-layer automobile paint sample (left). Video mosaic image of a paint-chip cross-section taken from the door of an automobile (right).

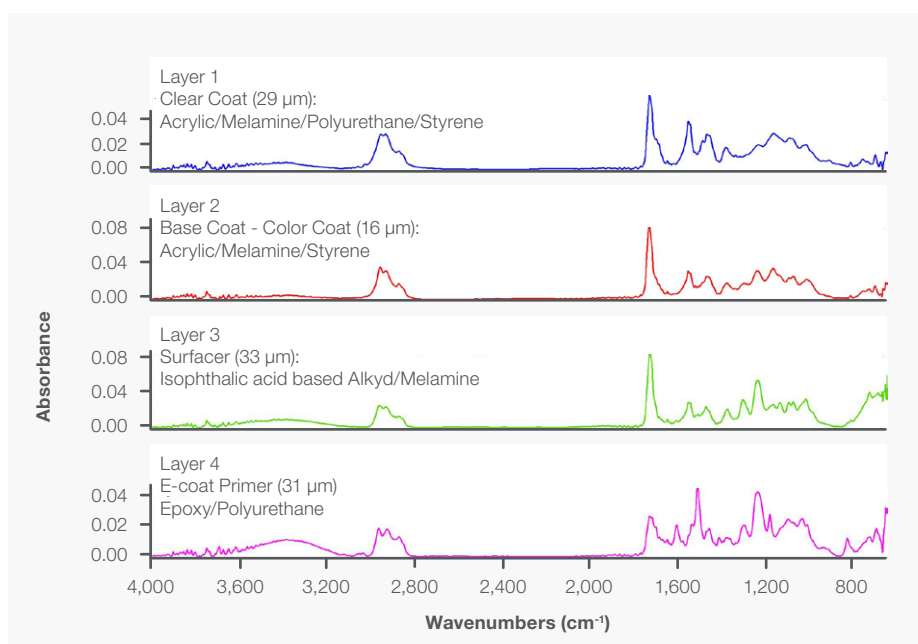
Figure 2. Representative FTIR spectra from the four identified layers in the door paint-chip cross-section. Infrared images are generated from peak areas associated with the various layers, which are then superimposed on the video images. The red areas show the location of the various layers. The infrared image covers an area of 370 x 140 µm² using a 10 x 10 µm² aperture and 5 µm steps.
