Root Cause Analysis of a Failed Plastic Cover

Thermo Fisher Scientific, Madison, WI, USA

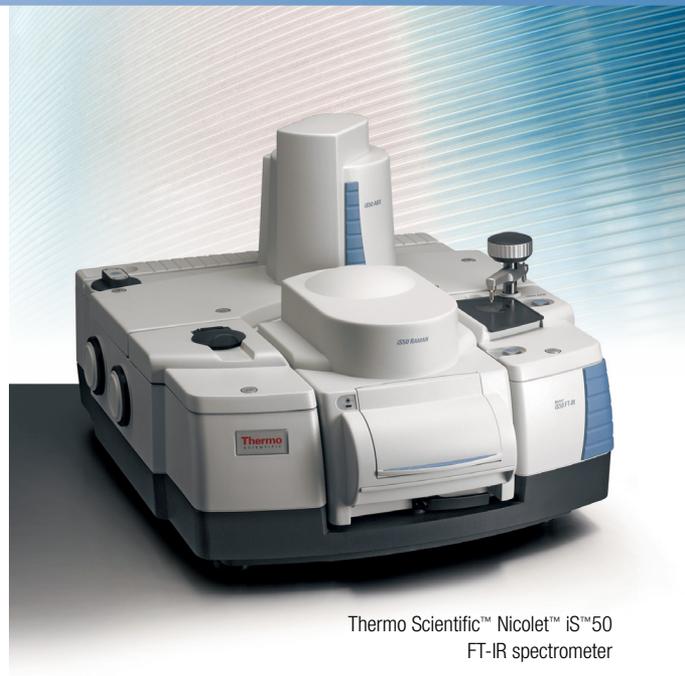
Thermo Scientific™ Nicolet™ iS™50
FT-IR spectrometer

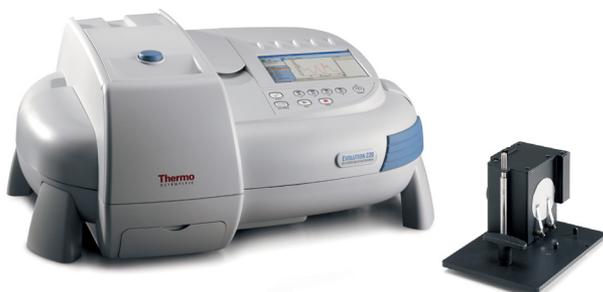
Figure 1: Evolution 220 UV-Visible spectrophotometer (left), and sample compartment integrating sphere accessory (right)

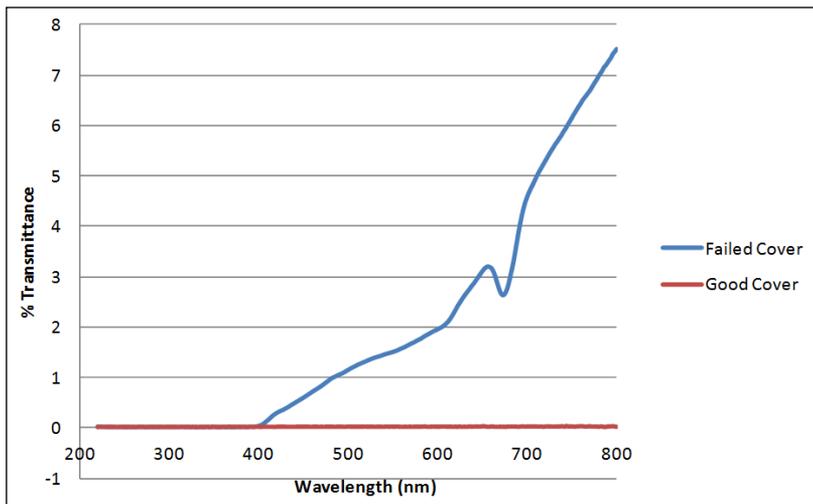
Figure 2: Diffuse Transmittance UV-Visible spectra of the failed cover (blue) and good cover (red), collected with an Evolution 220 UV-Visible spectrophotometer and integrating sphere accessory

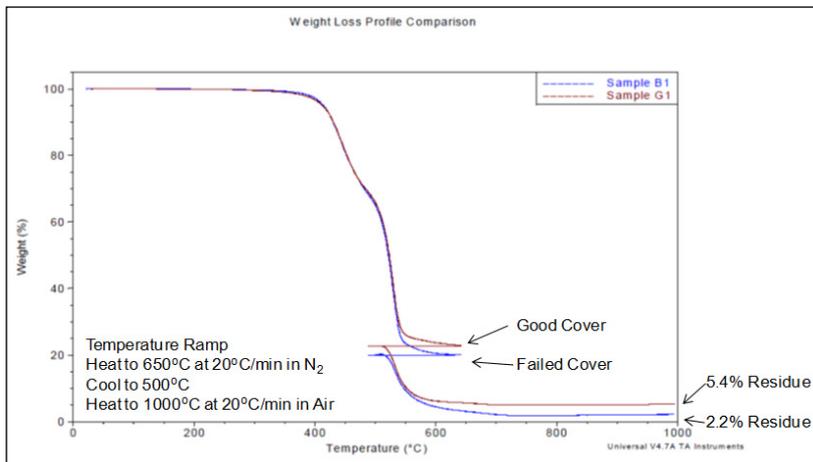
Figure 3: Thermogravimetric analysis weight loss curves for the good cover (red) and failed cover (blue), showing that the good cover has significantly higher inorganic content than the failed cover

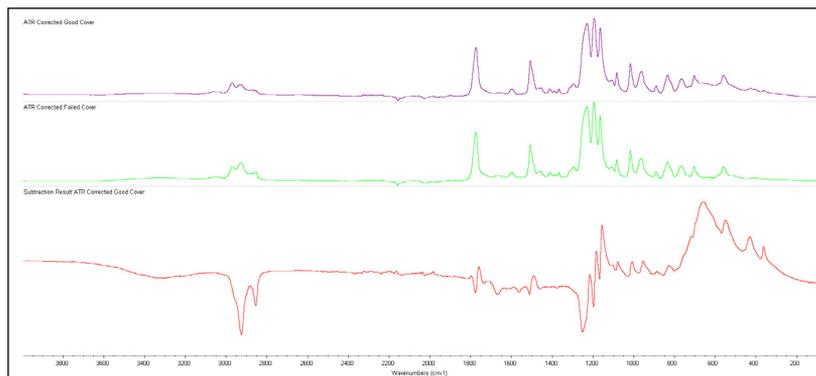
Figure 5: Advance ATR corrected infrared ATR spectra of the good plastic cover (top), failed plastic cover (middle) and difference spectra between the two (bottom)

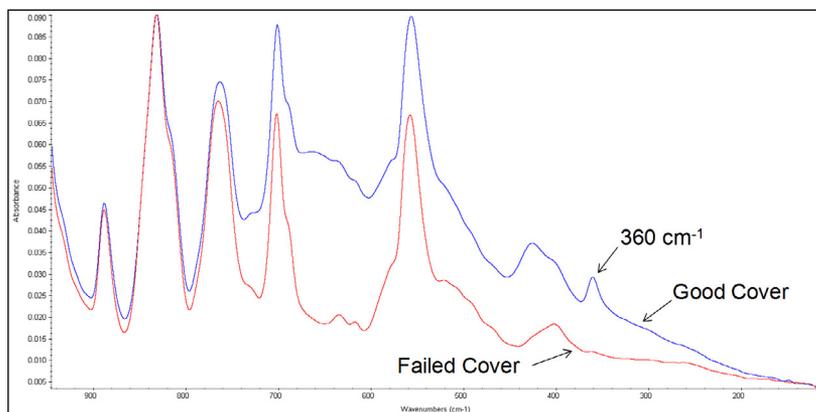
Figure 6: Overlay of the advanced ATR corrected spectra of the good cover (blue) and failed cover (red), over the spectral region from $940\text{ to }100\text{ cm}^{-1}$. Note the elevated baseline and the absorbance band at 360 cm^{-1} in the spectrum of the good cover that are absent or highly reduced in the spectrum of the failed cover.

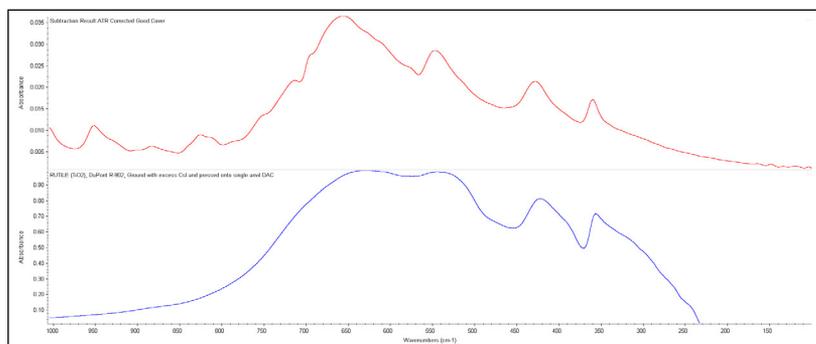
Figure 7: FT-Raman difference spectrum between the good and failed covers (blue), and top match from a library search against a forensic automobile paint pigment and fillers library (red), identifying a higher concentration of rutile (titanium dioxide) in the good cover.

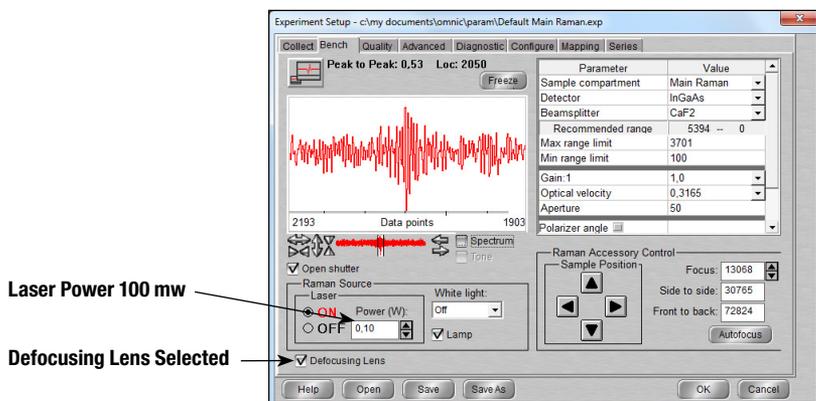
Figure 8: OMNIC software Raman control screen showing the settings for laser power and selection of the defocusing lens for collection of the FT-Raman spectra of the good and failed covers. As noted in the text, reduced power and defocusing of the laser was necessary to avoid sample damage on the good cover.

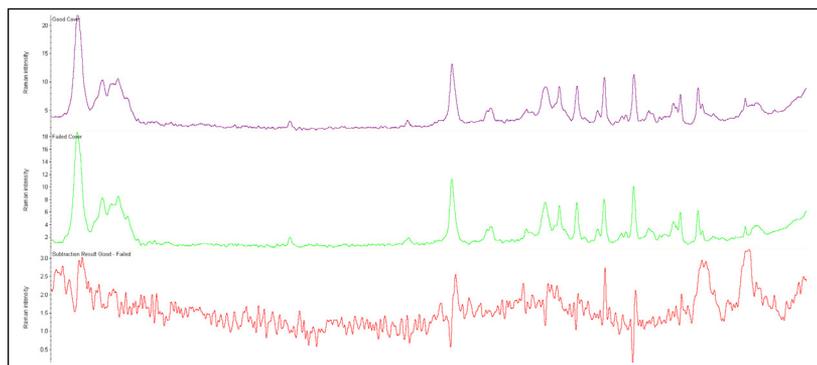
Figure 9: FT-Raman spectra of the good cover (top), failed cover (middle), and subtraction result between the two (bottom)

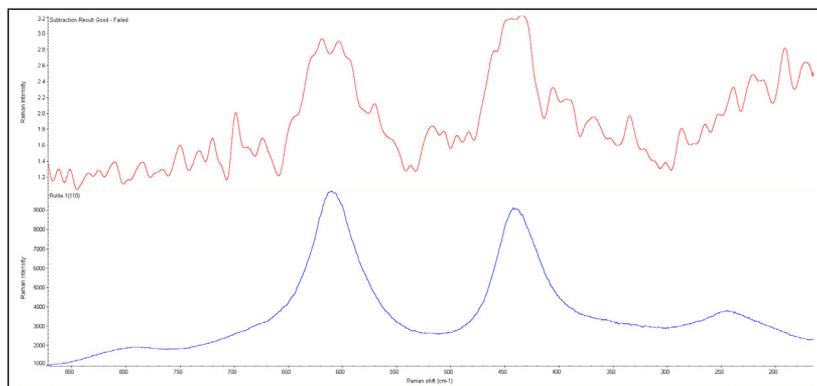
Figure 10: FT-Raman difference spectrum between the good and failed covers (top), and top library search result against a minerals Raman library (bottom), identifying a higher concentration of rutile (titanium dioxide) in the good cover
