Results of Using Re-washed Vials and Closures

Loy Shick, Thermo Fisher Scientific, Rockwood, TN, USA
Brian King, Thermo Fisher Scientific, Runcorn, Cheshire, UK

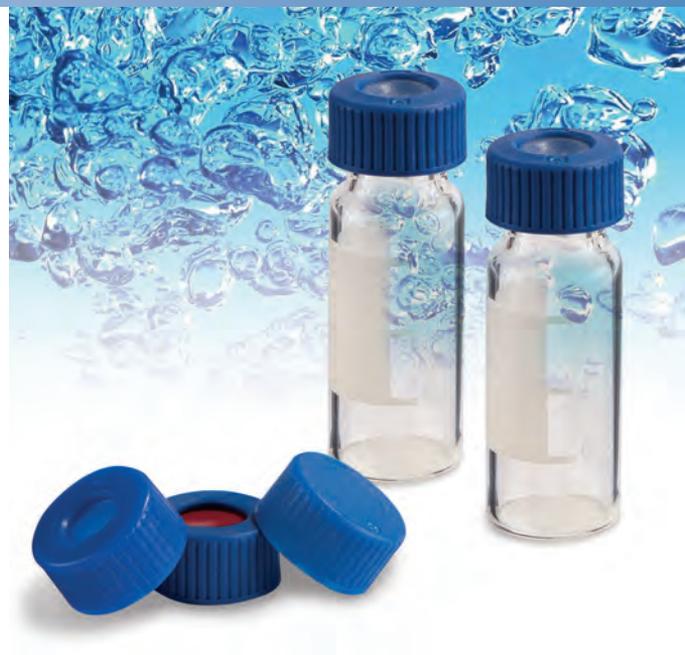
Physical Effects of Re-washing

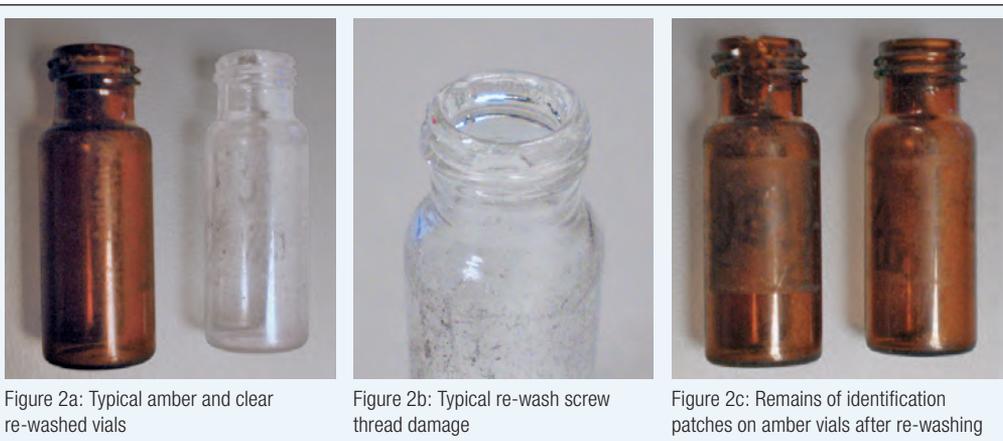
Figure 2a: Typical amber and clear re-washed vials

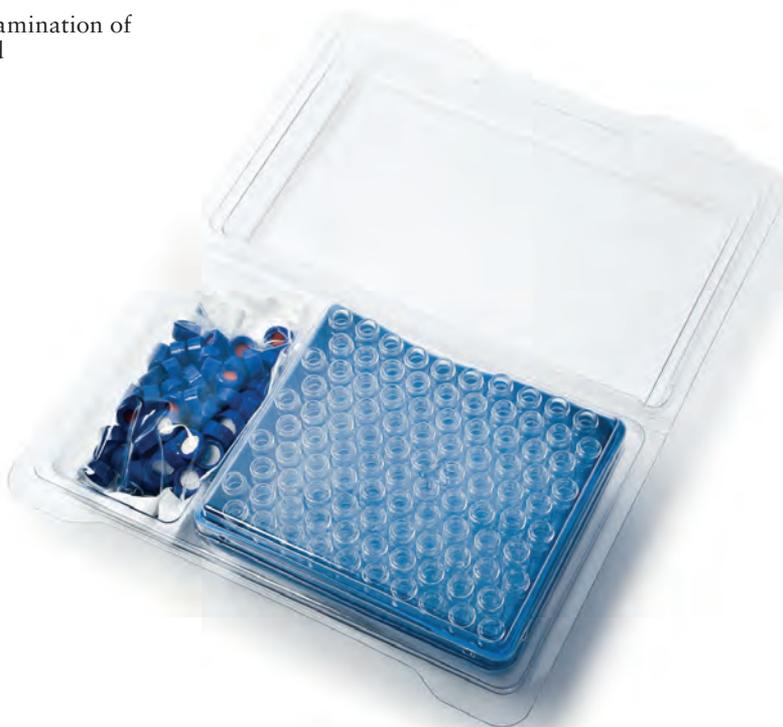
For more information, visit our website at www.thermoscientific.com/vials
