Results of using re-washed vials and closures

Loy Shick, Thermo Fisher Scientific,
Rockwood, TN, USA

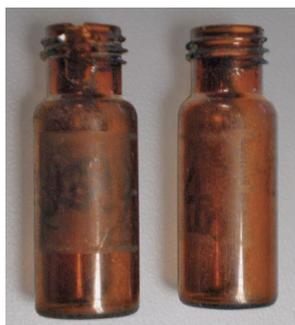
Figure 2c. Remains of identification patches on amber vials after re-washing

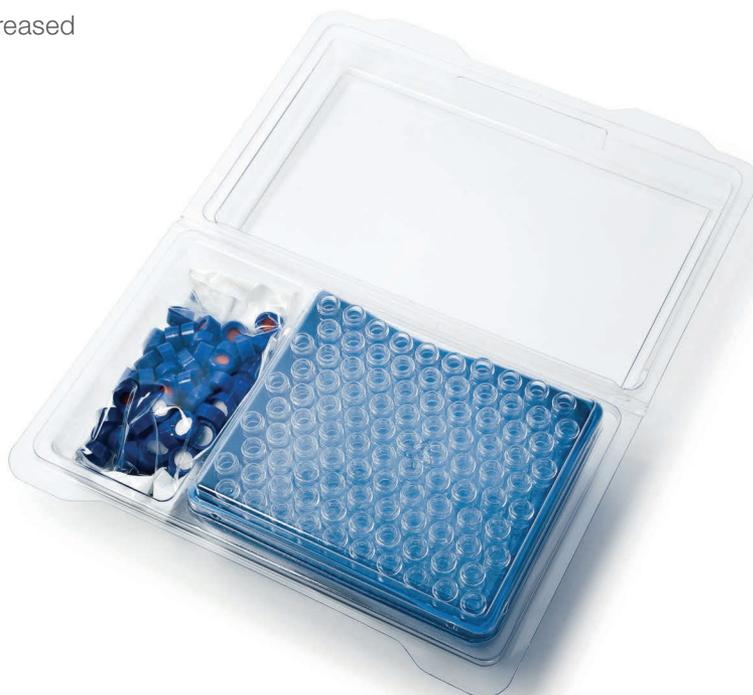
Find out more at thermoscientific.com/vials
