Microstructural and chemical evaluation of a thermally cycled thermal barrier coating system

Introduction

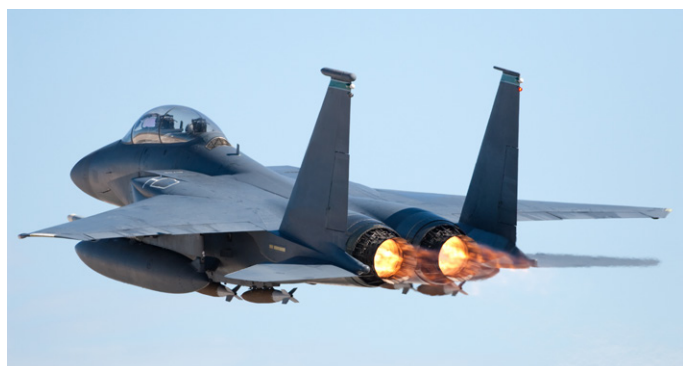
Figure 1. A jet fighter taking off with full afterburner.

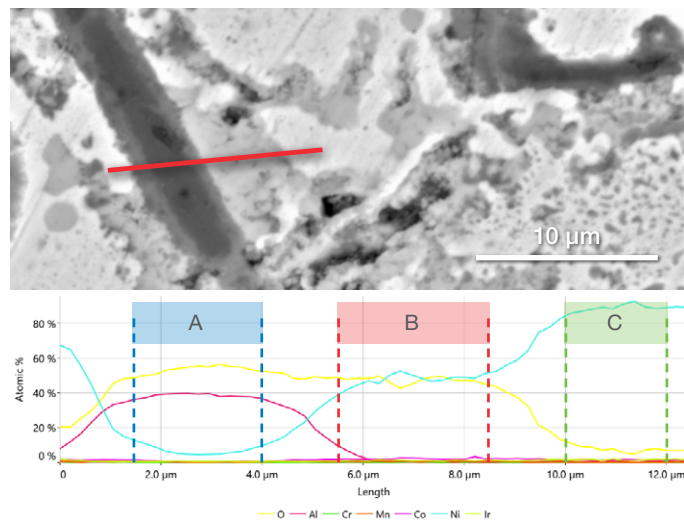
Figure 11. Top image shows the line where the linescan has been acquired. It covers the three different phases highlighted in the previous image (Acc voltage 25 keV, total acquisition time 180 s, average count rate \approx 10 kcps).
