TEM Server 7.10

Service Release Notes

Revision 7.10.1 • 17-DEC-2021

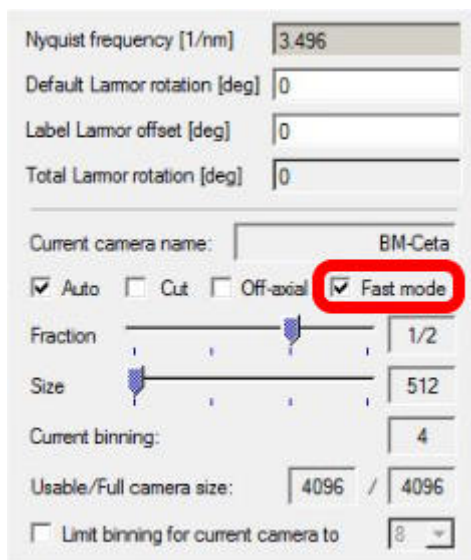
- Corrector PC: New Linux Kernel version 7.10.
- Image Corrector:
The new CEOS 5.4.6 software introduces *Fast mode* for continuous acquisition.

The Fast mode setting is stored. When selected, it will *not* be reset when the Corrector UI is closed.
