# Series 1405 TEOM Firmware Upgrade

## Version 1.74.00

These instructions describe how to perform a firmware upgrade to version 1.74.00 for a series 1405 instrument. It describes the differences between firmware versions, how to unpack the firmware files, and how to install them on the instrument. There are two different ways to perform a firmware update, via an Ethernet connection (with or without a router) using **ePort** software or via a USB FLASH drive (for this method, see Instrument Firmware Upgrade Instructions in this document for Ethernet-Based or USB-Based upgrades).

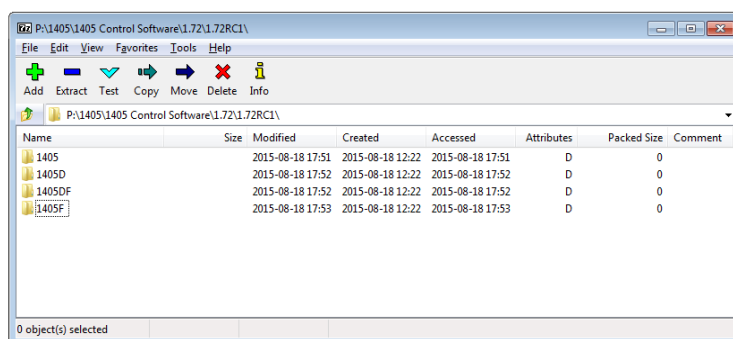
3. Navigate to the directory in which the instrument firmware package resides, just like in the Windows File Manager.

4. Select the directory in which the instrument firmware package resides, then either double-click on it or click **File > Open**. The Open Archive dialog box should appear.

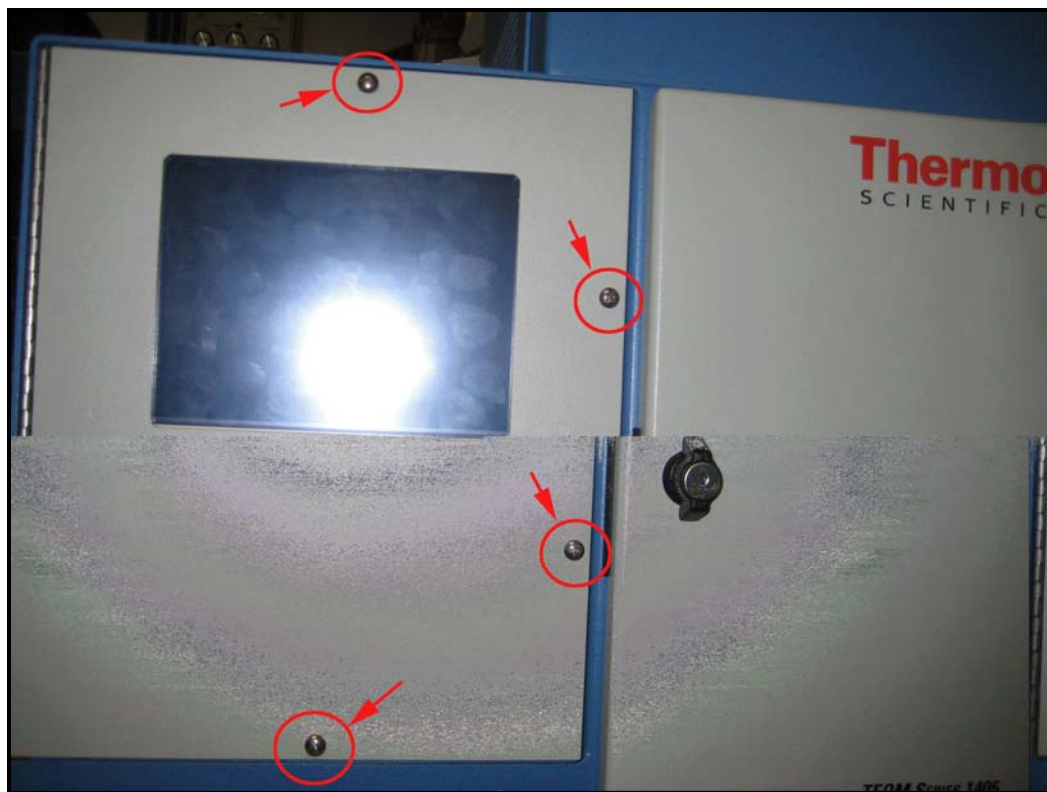
**Figure 1 – Front Cover Screws**

5. IMPORTANT: For safety reasons, disconnect the AC power to the instrument.
6. The next steps are only for 1405 instruments that contain an old style of a circuit board called an Interface board (most 1405 systems built in the year 2009 and prior have an old style Interface board), so this step determines which style board is present. If the firmware upgrade is being performed on an instrument with an old style interface board, additional steps need to be performed first.
  - a. As shown in the figure below, unscrew the (4) screws on the front left side of the 1405's enclosure. The door should swing open allowing internal access.

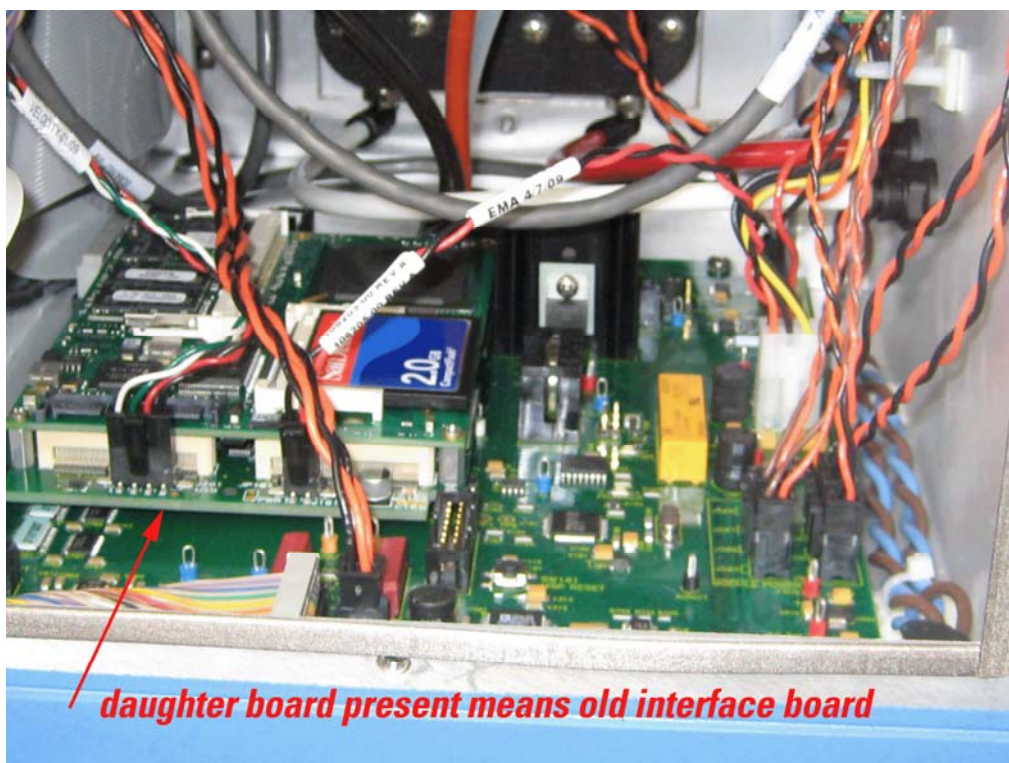
**Figure 2 – Daughter Board and Old Interface Board**

- b. Using the figure below as a guide, determine if there is a daughter board present in the system. The daughterboard is located in-between the Interface board below it and the CPU board (the CPU board is the board with the Compact Flash card in it) above it. If the daughterboard is NOT present as is shown, that means that the Interface board is a new style board, skip ahead to step 7 otherwise the Interface board is an old style board so continue the steps in the sequence.

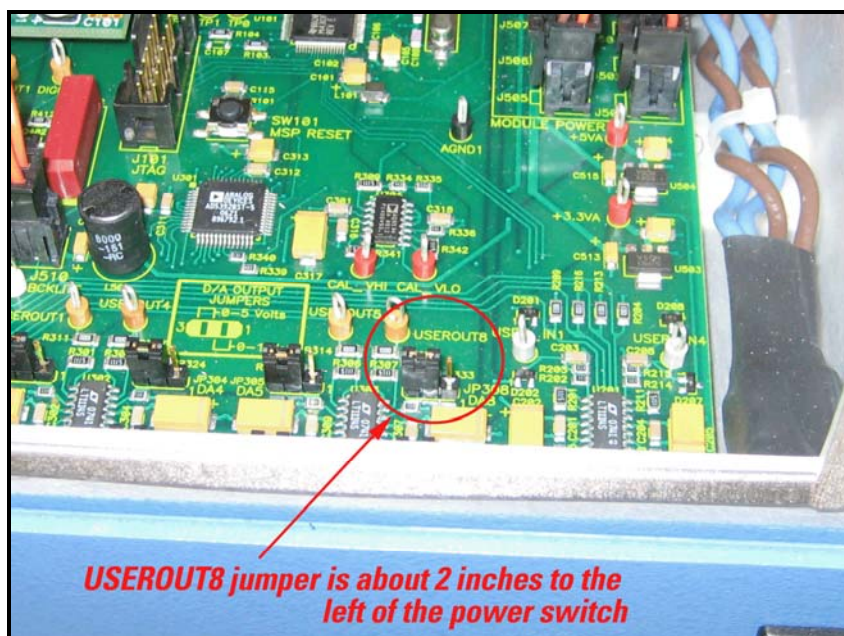
**Figure 3 – Jumper USEROUT8**

Locate the USEROUT8 jumper as shown in the picture below and remove it by grasping it with two fingers and pulling it up.

outputs are in use (or one or more are in use but some are skipped and the last one is used). Even if it's in use, it can be temporarily borrowed for the USB-based firmware update procedure and then returned afterwards – remember to re-install it after though, the procedure will remind you). The following steps assume that the USEROUT8 jumper is being borrowed.

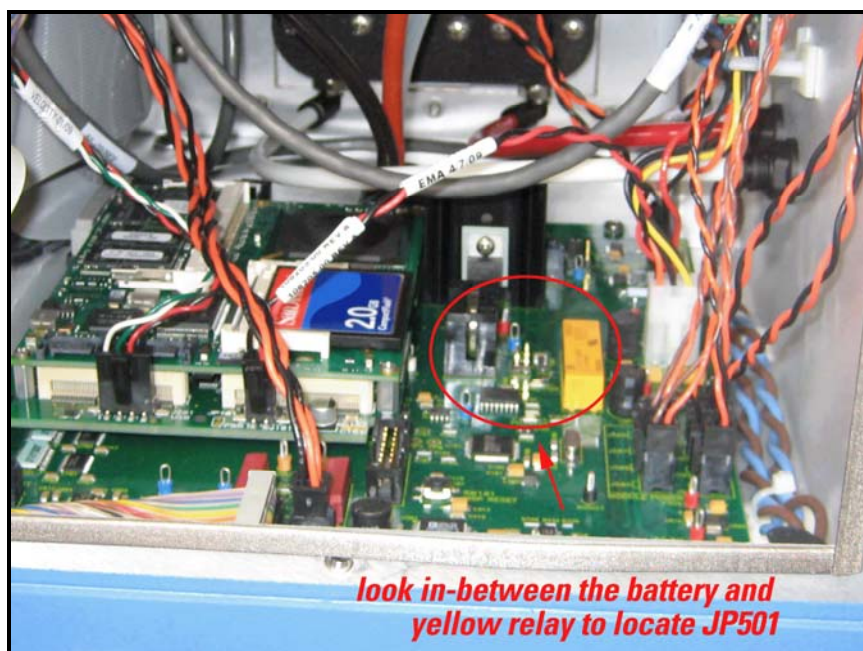
**Figure 4 - Jumper JP501 (wide view)**

8. *[Old style interface board present]* Install the jumper plug into the JP501 location as described below.
  - a. First, become familiar with the instrument's layout by using the picture below. Identify the general area that the JP501 jumper plug can be found. Look towards the center of the Interface board, in-between the small silver colored battery and the yellow relay.

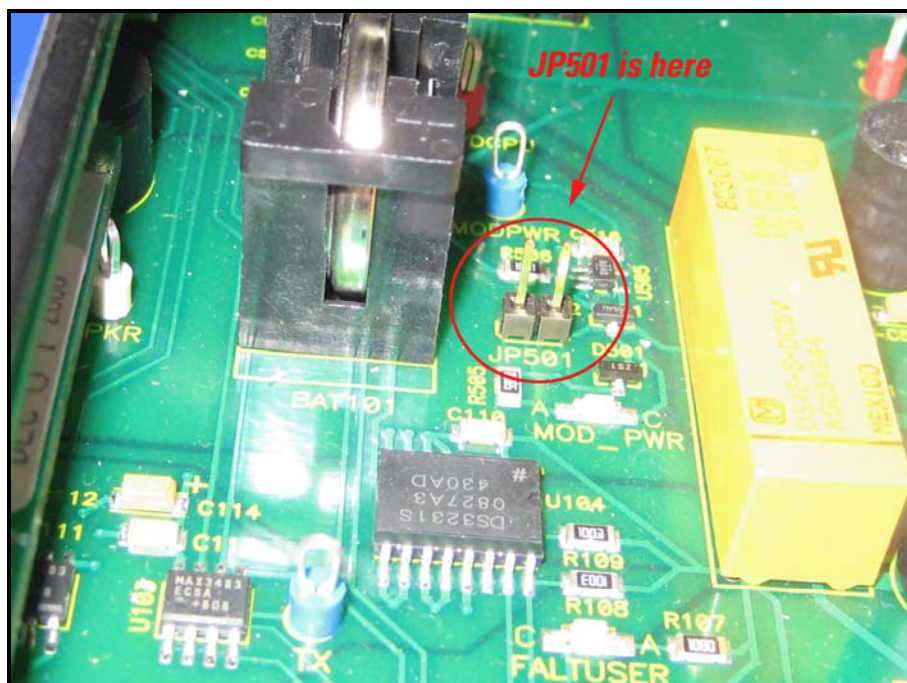
**Figure 5 - Jumper JP501 (detailed view)**

- b. Next, locate the exact position of JP501 using the following picture.

- c. Finally, grasp the jumper plug using two fingers, find the open end of the jumper plug, and reach in and install it on JP501 by placing the open end over the pins and then pushing down on it.
